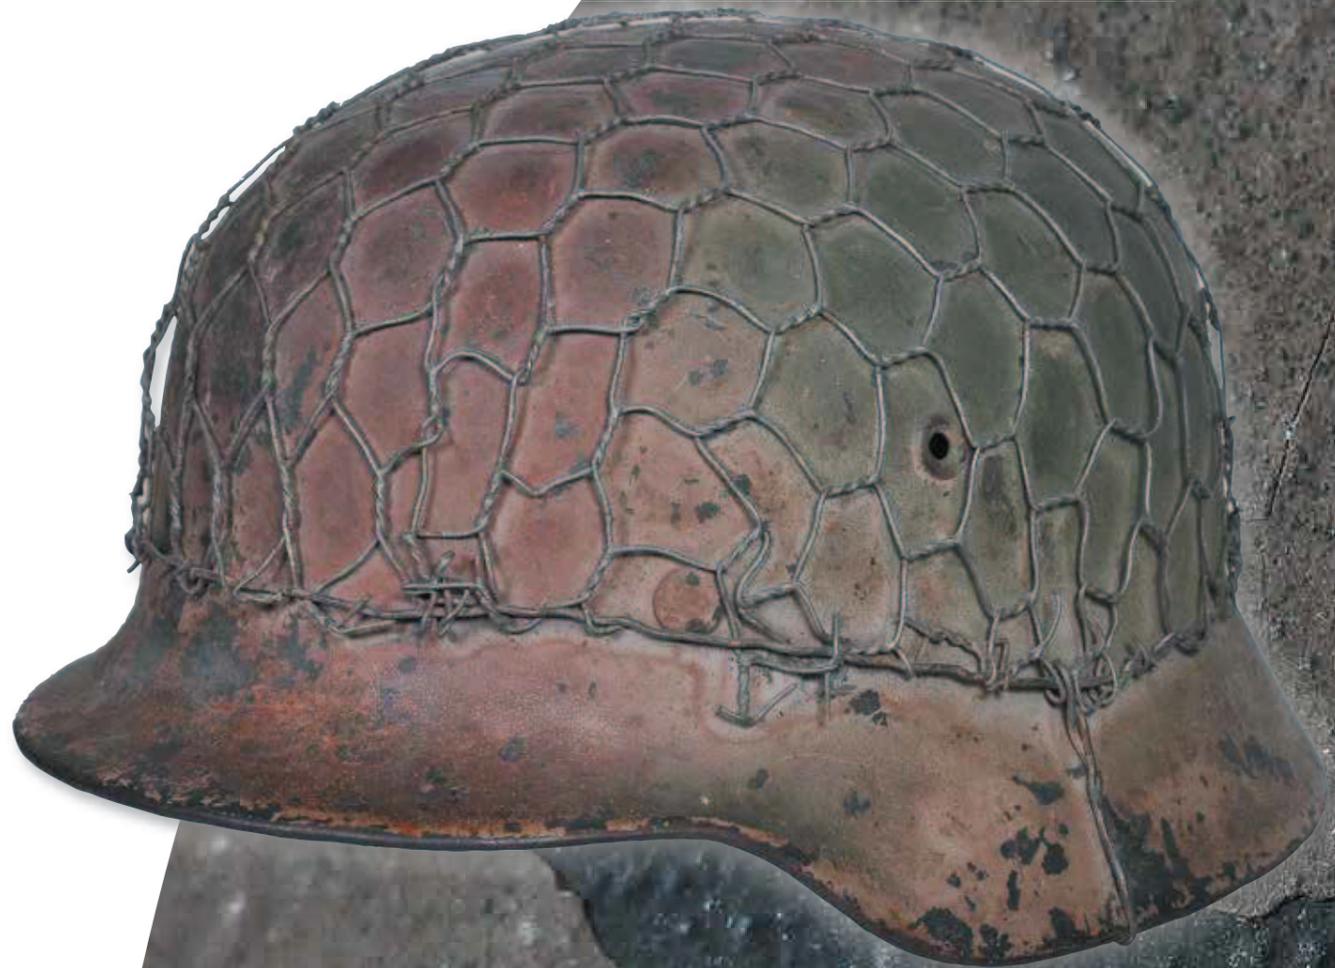
A very close-up image showing the fine crackled surface to the thickly pigmented dunkelgelb finish, through the areas of chipping one can see the original lightly granulated factory applied camouflage paint in the typical M.40 regulation slate grey finish. The tones of this helmet have become subdued due to extreme dryness and this completely untouched example speaks volumes about the passage of time and how it effects painted surfaces. One can clearly make out light rust bleed and it would appear that the red brown element of the sprayed camouflage finish was probably thinned to a high degree prior to application and has thus been applied in a semi red pinkish shade.

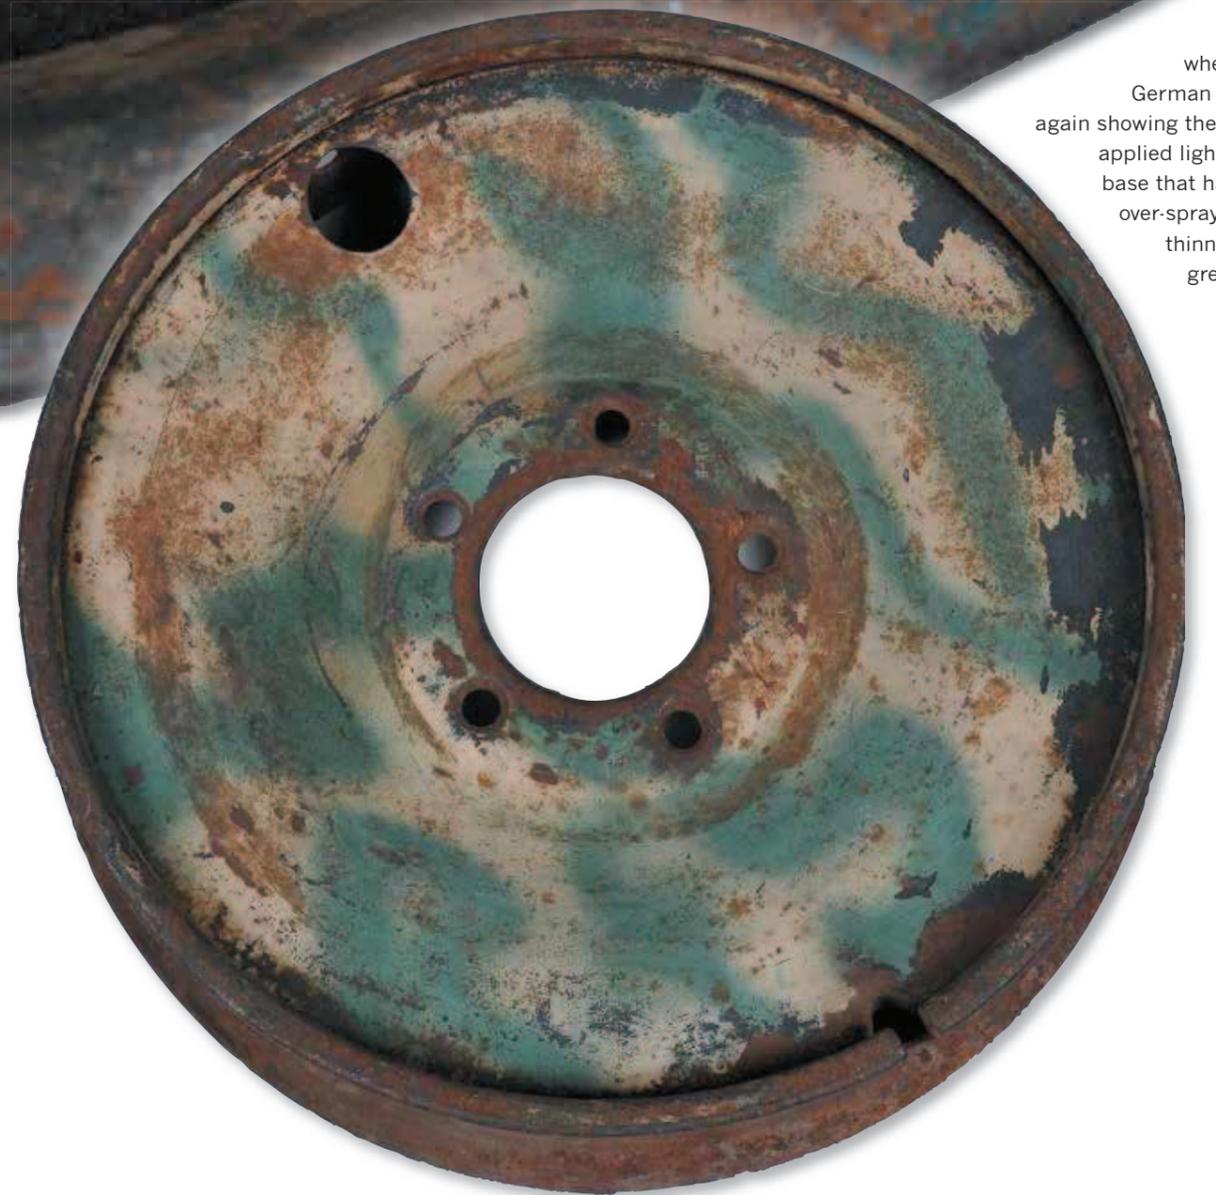
A road wheel for a German vehicle, again showing the factory applied light colour base that has been over-sprayed with thinned olive green type paint.

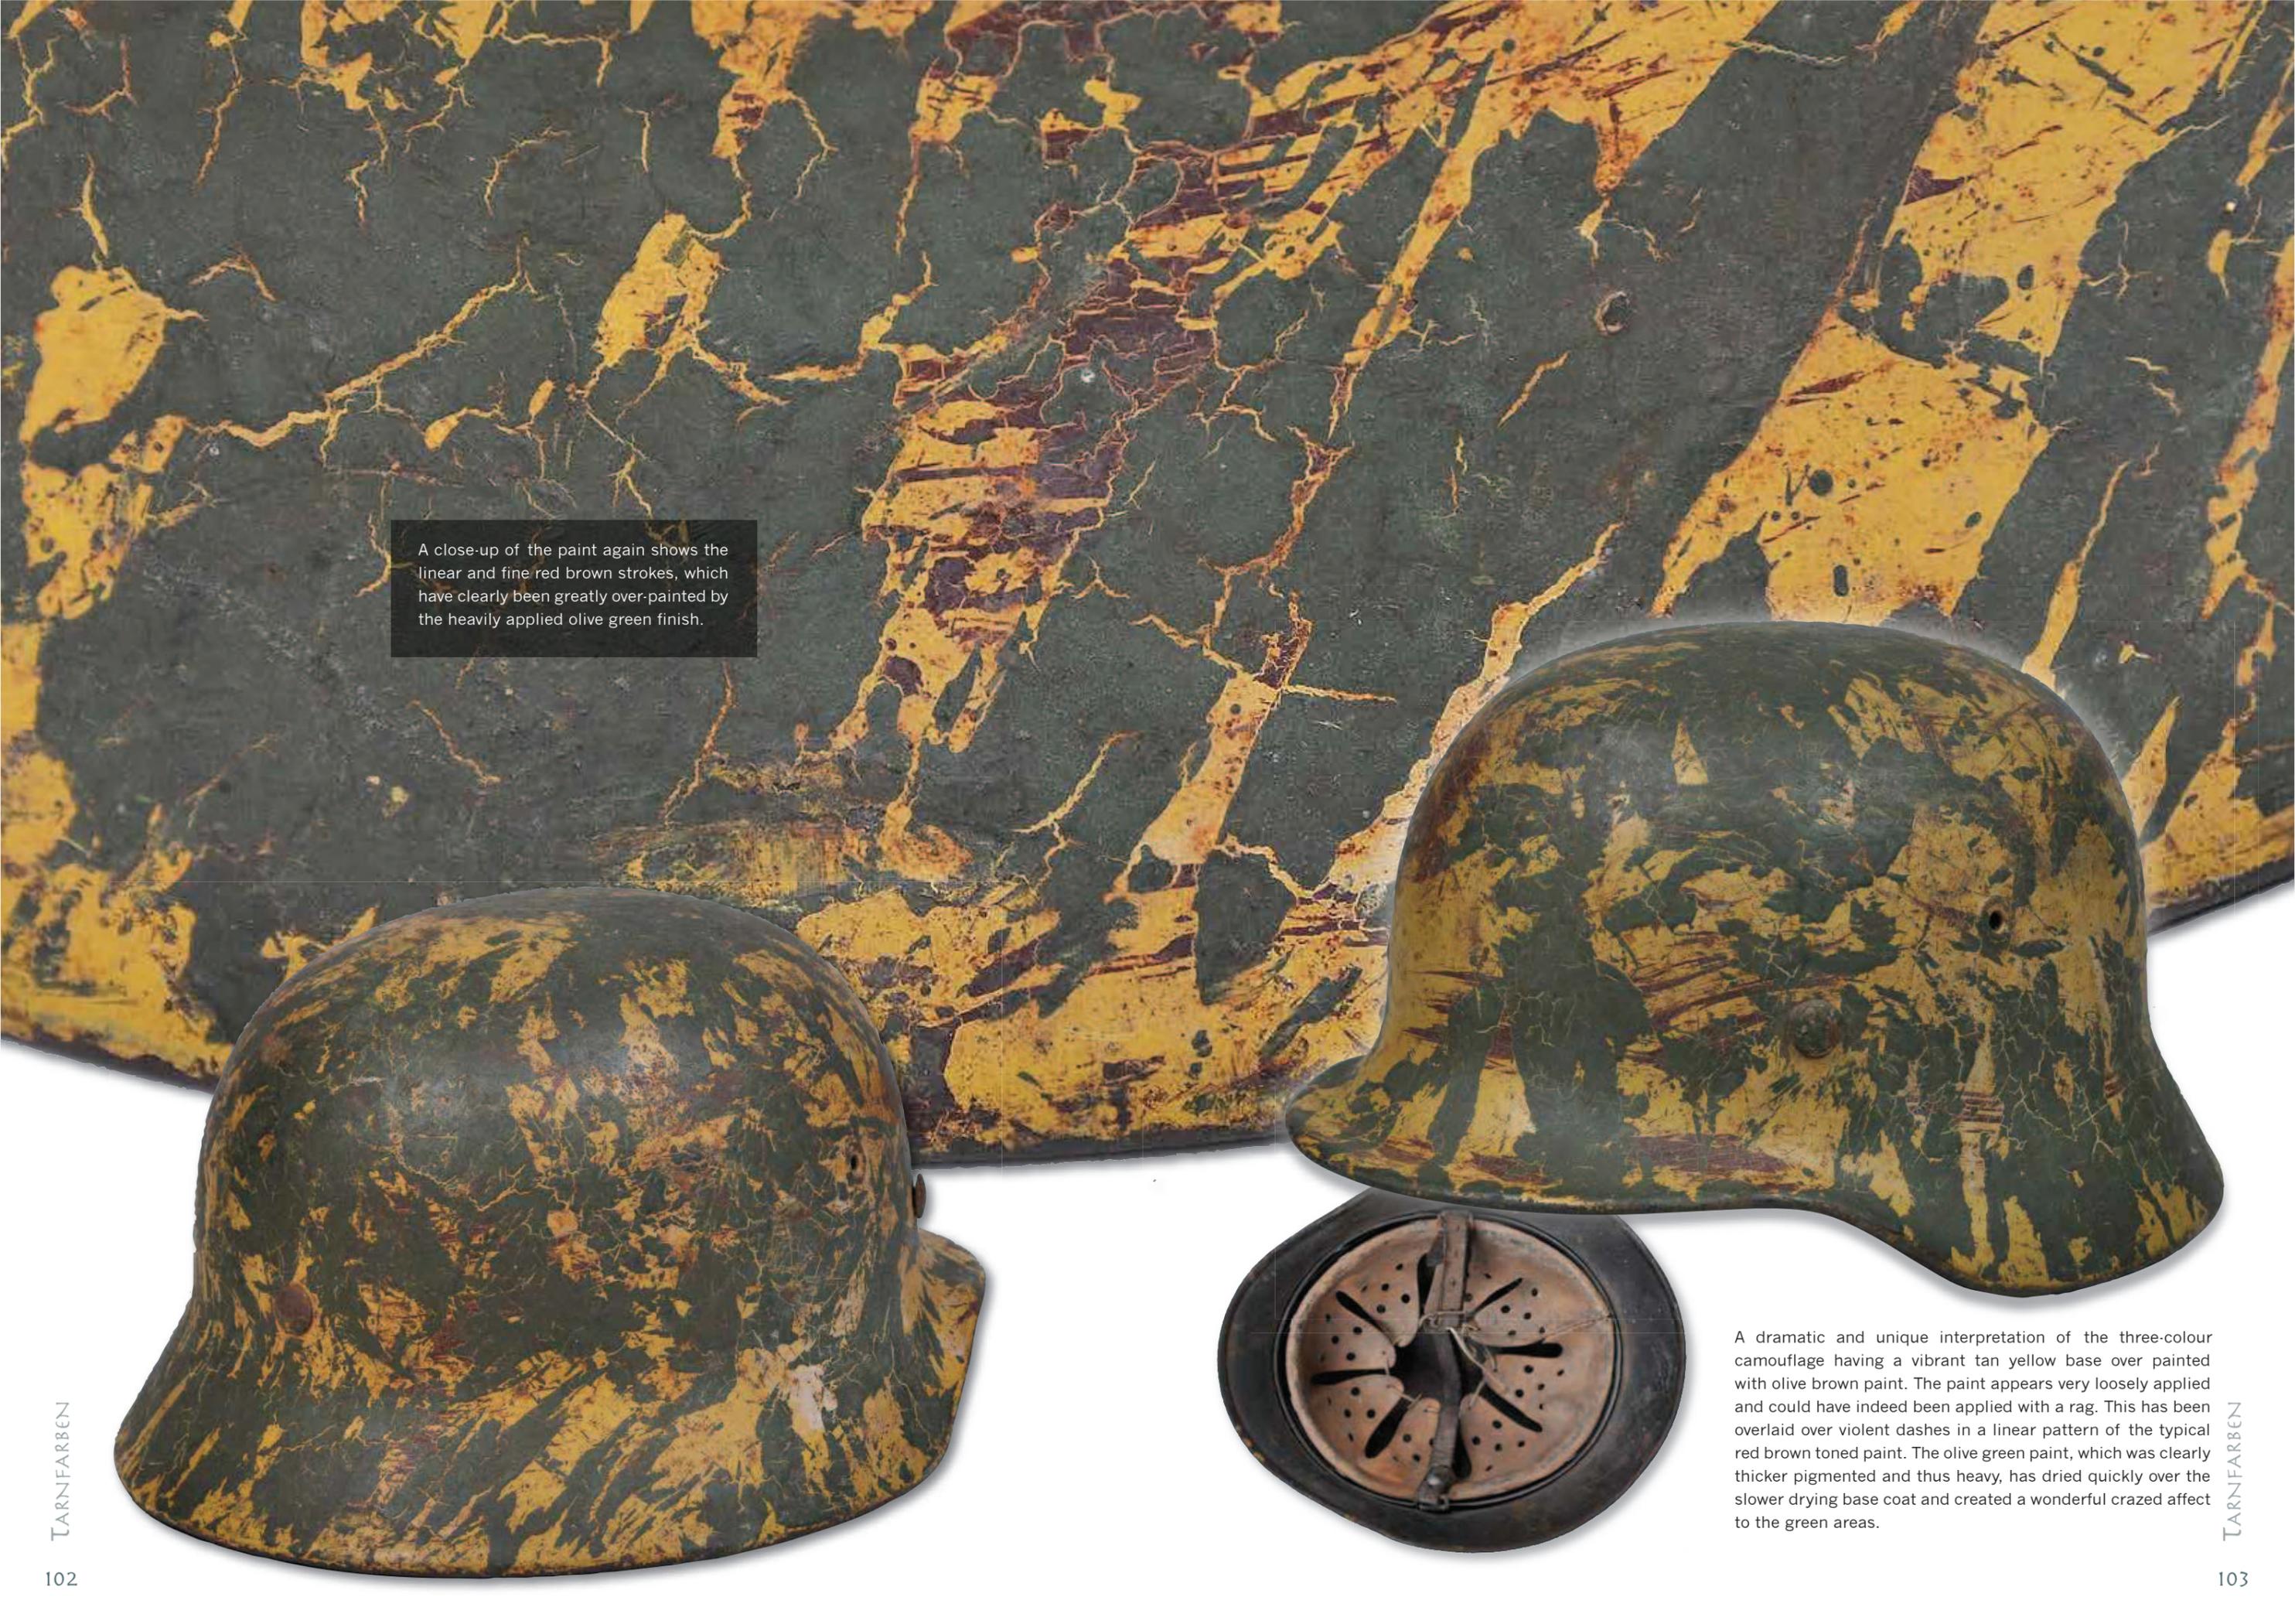
A close-up of the paint again shows the linear and fine red brown strokes, which have clearly been greatly over-painted by the heavily applied olive green finish.

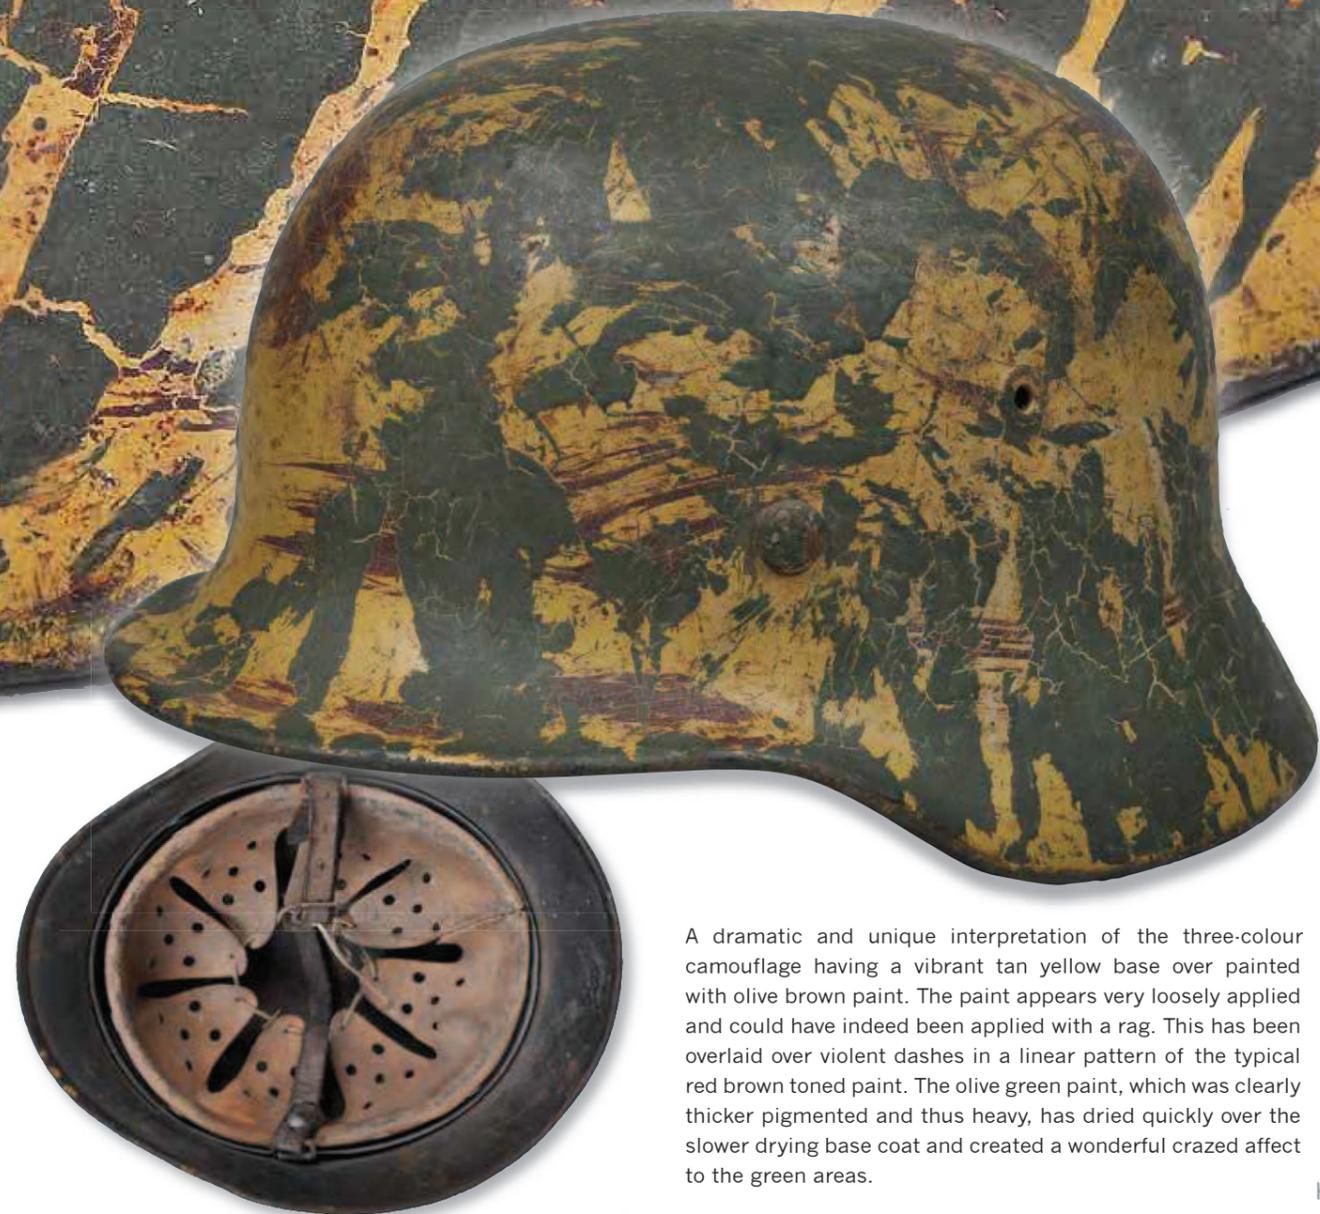
A dramatic and unique interpretation of the three-colour camouflage having a vibrant tan yellow base over painted with olive brown paint. The paint appears very loosely applied and could have indeed been applied with a rag. This has been overlaid over violent dashes in a linear pattern of the typical red brown toned paint. The olive green paint, which was clearly thicker pigmented and thus heavy, has dried quickly over the slower drying base coat and created a wonderful crazed affect to the green areas.
